Armstrong Chicken Farms Clean Water Act inspection (41 of 88 photos total)  
All photos taken by Kristine Karlson, EPA, on March 26, 2014.

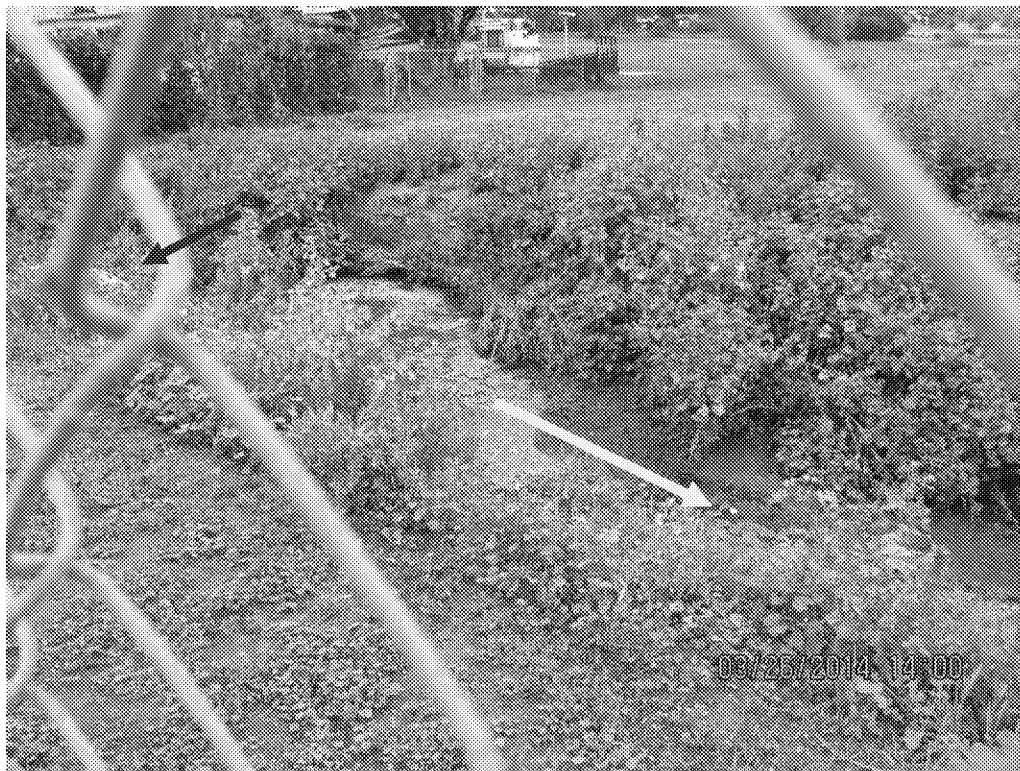
Photo 33 – Water collected in the drainage channel seen in the previous photo. Direction of flow is to the north (yellow arrow). A red arrow marks the outlet of the culvert.

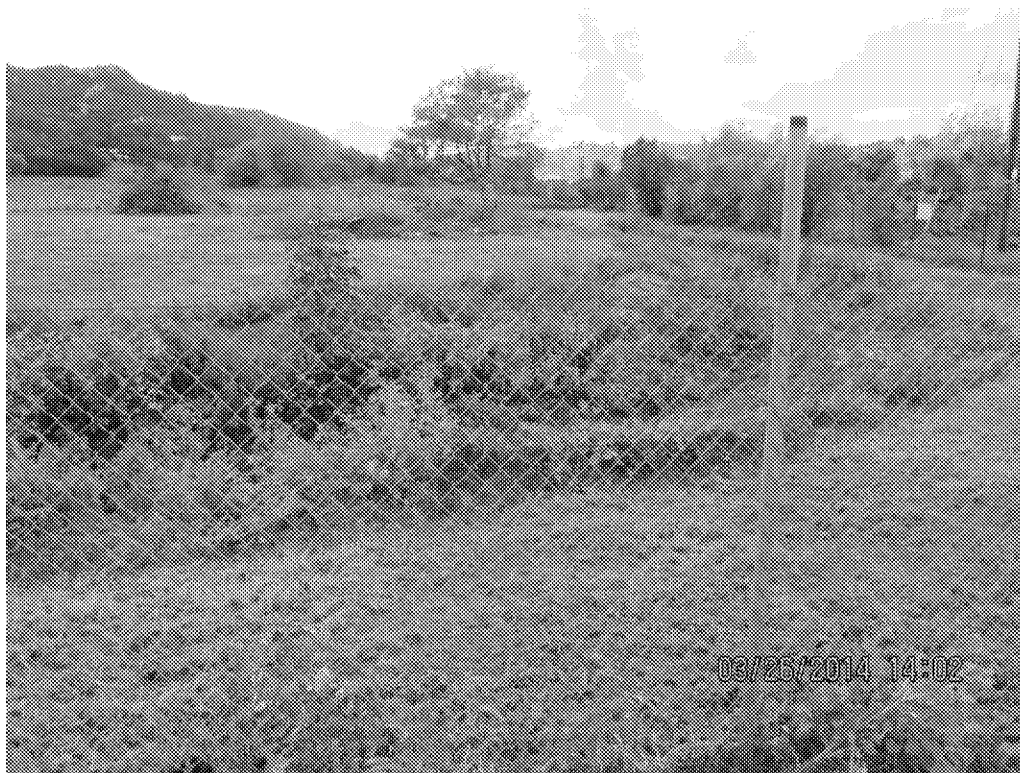
Photo 34 – Continuation of the channel seen in the previous two photos. The channel curves toward the west.

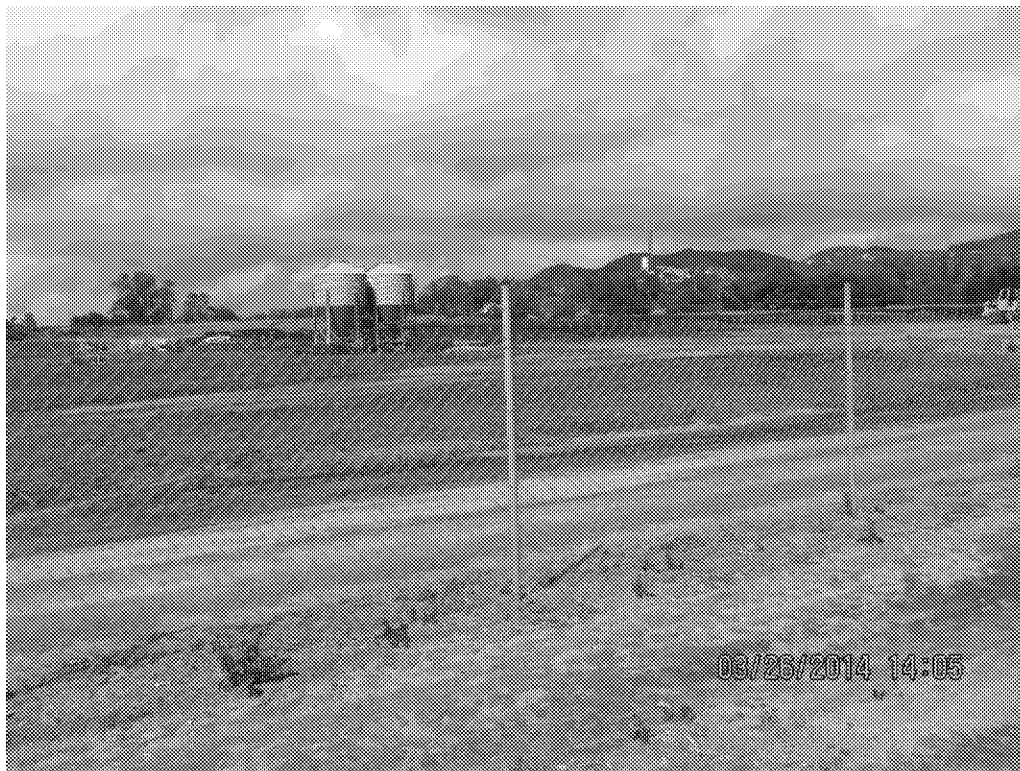
Photo 35 – This area, immediately to the north of the main egg farm, is where Mr. Armstrong reported that he land applies manure. It was not clear where the land application area was. From the south side of the fence and via aerial photography, it appears manure is arranged in rows similar to those in the center of the egg farm.
